# Manhole Inspection Summary

Manhole # S45E\_\_069MH

Insp Date: **7/23/08 8:57 AM**

**Location** Address: **1745 E Lombard St**

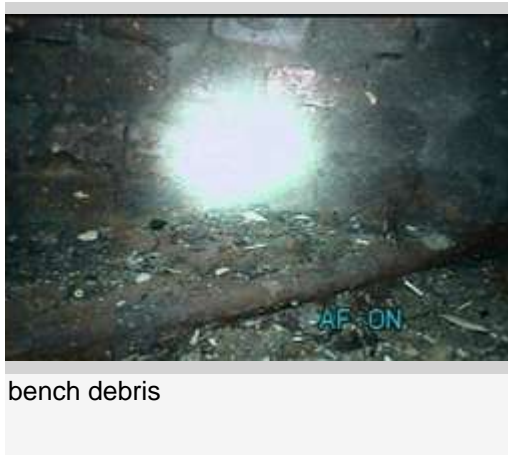
Defect 4

Condition: ☐ Sound ☐ Cracked ☐ Root Intrusion ☐ Deteriorated ☐ Leaks ☒ **Debris**

bench debris

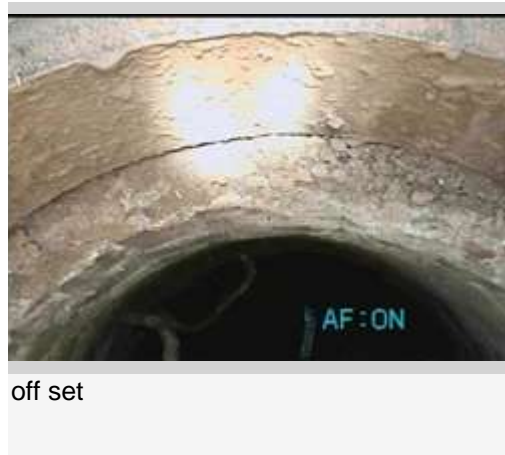
Defect 3

Offset: **1** (in.)

off set

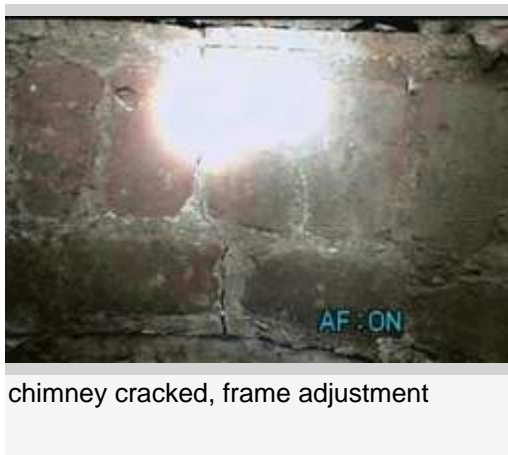
Defect 2

Condition: ☐ Sound ☒ **Cracked** ☐ Root Intrusion ☐ Loose Brick ☐ Deteriorated

chimney cracked, frame adjustment

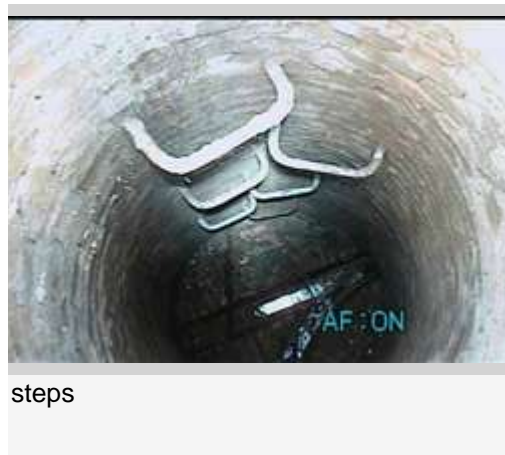
Defect 1

Count: **6** Missing: **0** ☒ **Corroded**

steps
